## Parking Lot & Area Lighting

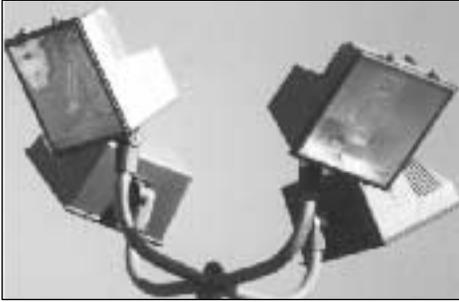
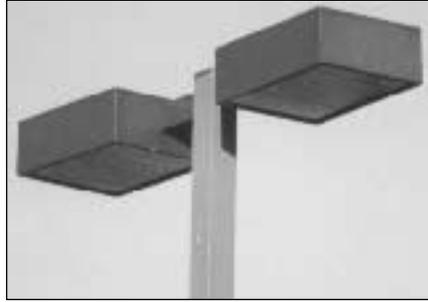
Floodlights such as those at far left should not be used to illuminate parking lots. When tilted as shown, they cause significant glare and light spillage. When lamp wattage is excessive, the problem intensifies and becomes disabling to our vision. The fixtures in the next photo are cutoff "shoe-box" type. At proper light levels, they perform the task effectively without unnecessary light pollution.

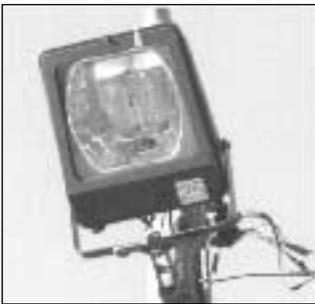
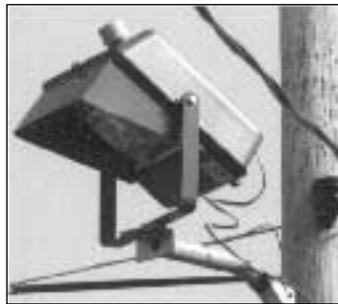
These fixtures are mounted on wooden utility poles. Many of these lights are very noticeable along major and minor roadways because they have been installed quite inappropriately. They are a source of considerable glare and unnecessary light spilling into adjacent property. The photo at far left shows such a fixture. The next photo shows a properly installed fixture. Note how it is aimed more downward and has a shield to prevent light-spillage.

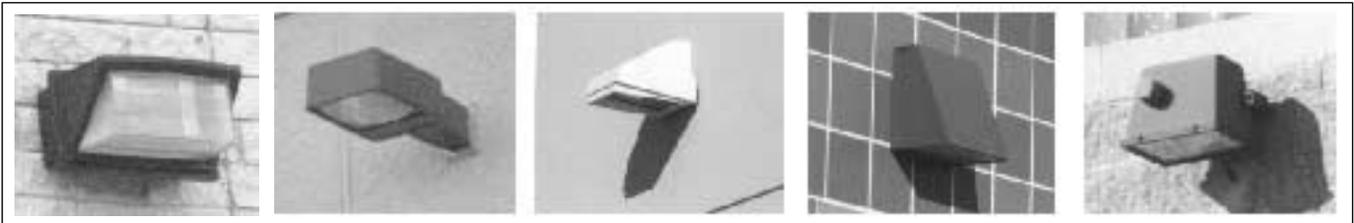
The fixture at far left is commonly referred to as a "wallpack" type. It represents a category of poorly designed luminaires that will perform most lighting tasks badly, casting glare in all unwanted directions. The remaining fixtures shown are all cutoff or equivalent. The fixture at far right is a floodlight installed in a cutoff position. The four fixtures at the right provide excellent lighting without unnecessary light pollution.
